InSight Condition Report

2018 Chevrolet Bolt EV LT 4dr Car Hatchback

1G1FW6S03J4109841 2,917 mi | Front Wheel Drive | Electric Motor | A/T | Hard Top | Cloth
 Lane/Run 23/176 Facilitation Manheim Pennsylvania Seller TESLA MOTOR INC

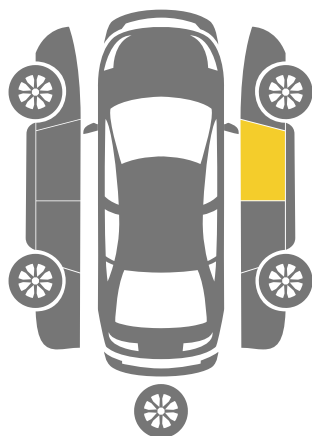
Damage Overview

Description	Condition Severity	Type	Image	Additional Info
● Windshield	Chipped < 1/8"	Miscellaneous		
● RF Door	Mult Dents/No Paint Dmg PDR/2	Cosmetic Conventional Paint and Body Not Required

Description	Condition Severity	Type	Image	Additional Info
● Warranty Books	Missing Replacement Required	Miscellaneous		
● Owners manuals	Missing Replacement Required	Miscellaneous		
● Maintenance Book	Missing Replacement Required	Miscellaneous

No structural damages reported

No other damages reported

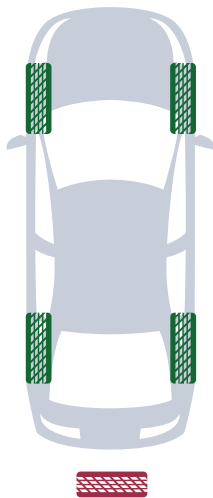
Tires & Wheels

Wheels Aluminum

Left Front
 MICHELIN
6/32"
 215/50R17.0

Left Rear
 MICHELIN
7/32"
 215/50R17.0

Right Front
 MICHELIN
6/32"
 215/50R17.0

Right Rear
 MICHELIN
7/32"
 215/50R17.0

Spare
 (None)
0/32"
