InSight Condition Report

2015 Nissan LEAF 4dr HB S

1N4AZ0CP2FC323370 25,981 mi | Front Wheel Drive | Electric Motor | A/T | Hard Top | Cloth
Lane/Run 2/115 Facilitation Manheim San Francisco Bay Seller NISSAN-INFINITI LT

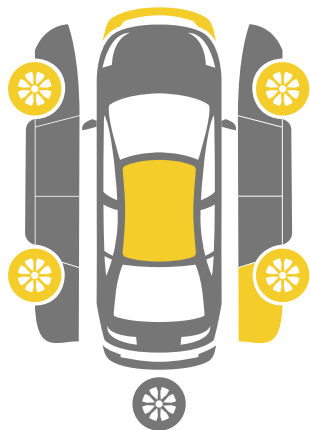
Damage Overview

Description	Condition Severity	Type	Image	Additional Info
● Front Bumper Cover	Dent/Paint Dmg 1" to 2"	Paint and Body Requires Conventional Repair		
● F Bumper Center Grille-Screen	Loose Repair Required	Miscellaneous		
● Left Drip Rail	Scratch Light GR 12"	Paint and Body Requires Conventional Repair		
● LF Wheel Cover	Curb Rash 1" to 2"	Miscellaneous		
● LR Wheel Cover	Curb Rash 1/2" to 1"	Miscellaneous		
● RR Wheel Cover	Curb Rash 1" to 2"	Miscellaneous		
● RR Tire	Mismatched None	Miscellaneous		
● R Qtr Panel	Dent/No Paint Dmg PDR/1	Cosmetic Conventional Paint and Body Not Required		
● RF Wheel Cover	Bent Replacement Required	Miscellaneous
