InSight Condition Report

2015 Kia Soul EV 5dr Wgn +

KNDJX3AE6F7002864 25,940 mi | Front Wheel Drive | Electric Motor | A/T | Hard Top | Leather
Lane/Run 2/207 Facilitation Manheim San Francisco Bay Seller KIA MOTORS FINANCE

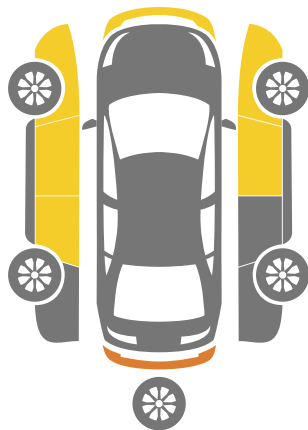
Damage Overview

Description	Condition Severity	Type	Image	Additional Info
● Front Bumper Spoiler	Curb Rash 2" to 3"	Miscellaneous		
● Front Bumper Cover	Scratch Heavy 1" to 2"	Paint and Body Requires Conventional Repair		
● Front Bumper Cover	Scratch Light 1" to 2"	Cosmetic Conventional Paint and Body Not Required		
● LF Door	Dent/No Paint Dmg PDR/1	Cosmetic Conventional Paint and Body Not Required		
● LF Door Edge	Scratch Heavy 1" to 2"	Miscellaneous		
● LF Fender	Dent/No Paint Dmg PDR/1	Cosmetic Conventional Paint and Body Not Required		
● LR Door	Dent/No Paint Dmg PDR/1	Cosmetic Conventional Paint and Body Not Required		
● Rear Bumper Cover	Mult Dents/Paint Dmg 2	Included Repairs fixed with Panel Repairs

● Rear Bumper	Prev Repair SubStd Wavy	Previous Repair

● Lift Gate	Chipped 8	Cosmetic Conventional Paint and Body Not Required		
● Lift Gate	Scratch Light 4" to 5"	Cosmetic Conventional Paint and Body Not Required

Description	Condition Severity	Type	Image	Additional Info
● RF Door	Scratch Light 1/8" to 1/2"	Cosmetic Conventional Paint and Body Not Required		
● RF Fender	Dent/No Paint Dmg PDR/1	Cosmetic Conventional Paint and Body Not Required		
● RF Fender	Scratch Heavy 1" to 2"	Cosmetic Conventional Paint and Body Not Required		
● RF Fender	Scratch Light 5" to 6"	Cosmetic Conventional Paint and Body Not Required

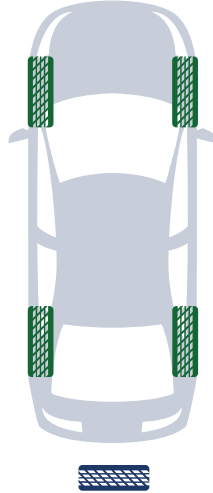
Tires & Wheels

Wheels Aluminum

Left Front
GENERIC
6/32"
205/60R16.0

Left Rear
GENERIC
8/32"
205/60R16.0

Right Front
GENERIC
6/32"
205/60R16.0

Right Rear
GENERIC
8/32"
205/60R16.0
