InSight Condition Report

2017 Nissan LEAF S Hatchback

1N4BZ0CP9HC303706 23,180 mi | Front Wheel Drive | Electric Motor | A/T | Hard Top | Cloth
Lane/Run 4/78 Facilitation Manheim Seattle Seller NISSAN-INFINITI LT

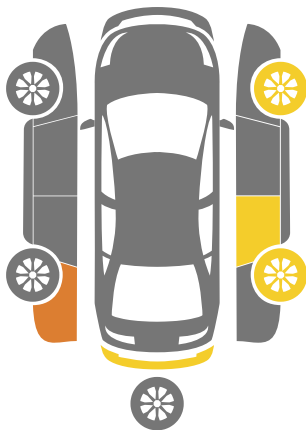
Damage Overview

Description	Condition Severity	Type	Image	Additional Info
● L Qtr Panel	Dent/No Paint Dmg 5" to 6"	Paint and Body Requires Conventional Repair

● Rear Bumper Cover	Heavy Mult Scratches 5	Paint and Body Requires Conventional Repair

● RR Door	Dent/No Paint Dmg PDR/1	Cosmetic Conventional Paint and Body Not Required		
● RR Wheel Cover	Bent Replacement Required	Miscellaneous

● RF Wheel Cover	Curb Rash 5" to 6"	Miscellaneous

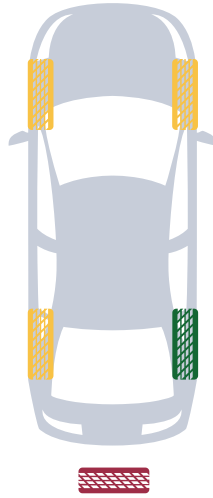
Tires & Wheels

Wheels Steel

Left Front
BRIDGESTONE
5/32"
205/55R16.0

Left Rear
BRIDGESTONE
4/32"
205/55R16.0

Right Front
BRIDGESTONE
5/32"
205/55R16.0

Right Rear
BRIDGESTONE
6/32"
205/55R16.0

Spare
(None)
0/32"
