InSight Condition Report

2016 Kia Soul EV 5dr Wgn +

KNDJX3AE4G7013251

20,497 mi | Front Wheel Drive | Electric Motor | A/T | Hard Top | Premium Synthetic

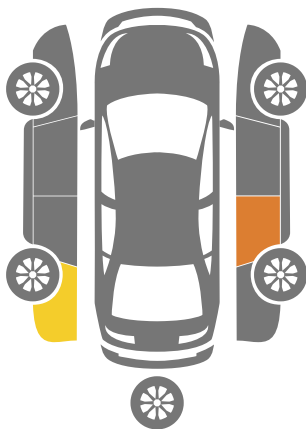
Damage Overview

Exterior (2)

| Description | Condition Severity | Type | Image | Additional Info |
|---|---|--|--|---|
| ● L Qtr Panel | Dent/No Paint Dmg PDR/1 | Cosmetic Conventional Paint and Body Not Required | | |
| ● RR Door | Mult Dents/Paint Dmg 2 | Paint and Body Requires Conventional Repair | | |

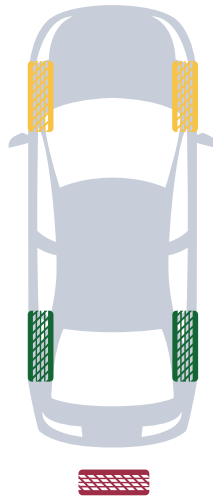
Tires & Wheels

Wheels Aluminum

Left Front
 NEXEN
5/32"
 205/60R16.0

Left Rear
 NEXEN
7/32"
 205/60R16.0

Right Front
 NEXEN
5/32"
 205/60R16.0

Right Rear
 NEXEN
7/32"
 205/60R16.0

Spare
 (None)
0/32"
